SICK BUILDINGS:

Case Studies of Tight Building Syndrome and Indoor Air Quality Investigations in Modern Office Buildings

CASE STUDY 1: DIAGNOSING AN INDOOR ENVIRONMENT PROBLEM

CASE STUDY 2: HOW SICK IS A SICK BUILDING?

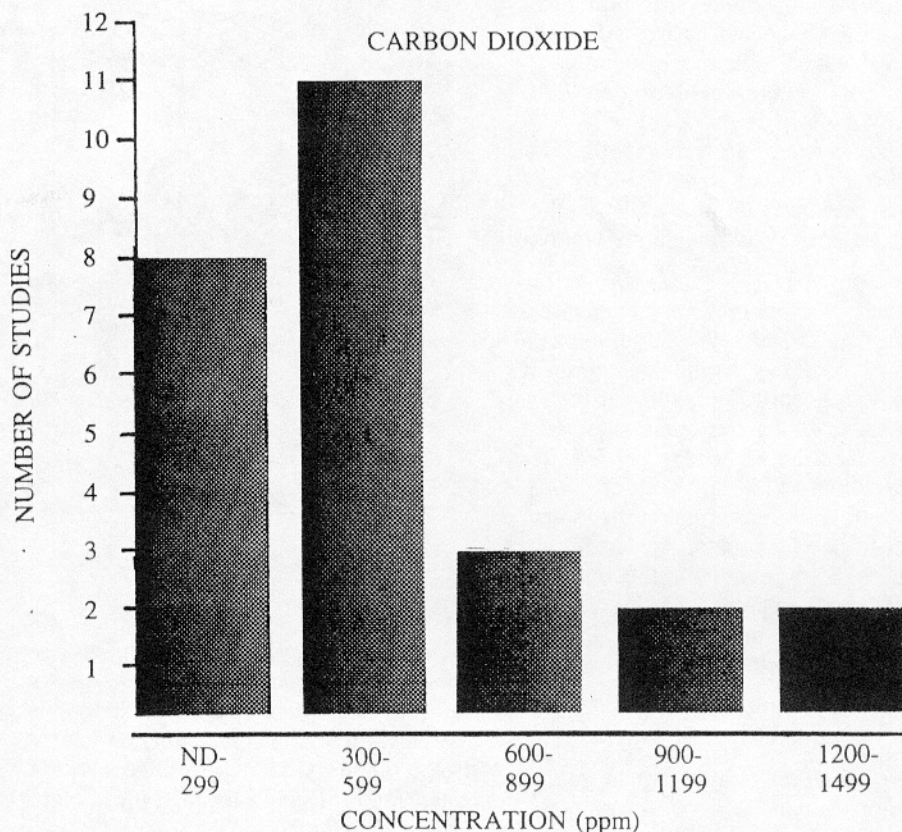
FIGURE 1: Graph of Carbon Dioxide Ranges Measured in 26 Building Studies

Carbon dioxide concentrations measured at selected locations on all occupied office floors are presented in Table 4. Carbon dioxide levels are higher than those normally found in similar air conditioned office buildings. For example Figure 1 is a graph of the distribution of CO₂ levels measured in 26 office buildings contained in the Building Performance Database (Sterling *et al.*, 1985b). The concentration of CO₂ measured in Building A is higher than that found in the majority of buildings.*
