SICK BUILDINGS:

Case Studies of Tight Building Syndrome and Indoor Air Quality Investigations in Modern Office Buildings

CASE STUDY 1: DIAGNOSING AN INDOOR ENVIRONMENT PROBLEM

CASE STUDY 2: HOW SICK IS A SICK BUILDING?

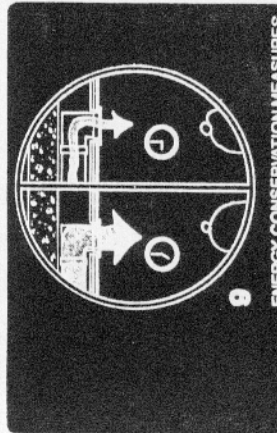
9
ENERGY CONSERVATION MEASURES

Energy conservation methods usually involve reduction of fresh air ventilation rates. Reduction of the fresh air supply increases the rate of accumulation of pollutants by reducing the volume of air exhausted. The efficiency of standard air filters and their ability to control contaminants is reduced substantially as the velocity of the ventilation air is lowered. Many buildings now use a Variable Air Volume system. This VAV only introduces fresh air when cooling or heating is required, not when vent is required. Occupants of buildings with the VAV system often complain of stale, stuffy air, an indication of insufficient ventilation.
